**Electrical
Safety
Solutions for
Yachts and
Cruise Liners**

Luxury should be safe too

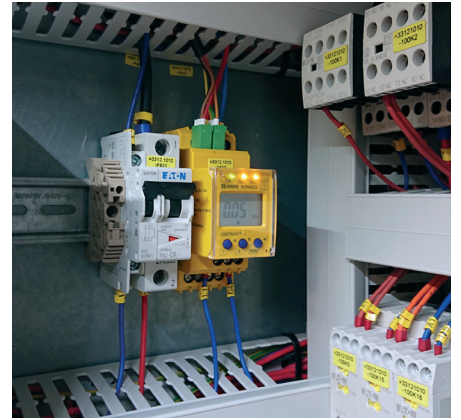
Residual current monitoring with the RCMA423 residual current monitor

To set up residual current monitoring of the earthed system safely and permanently, the operator has enhanced the central earth fault monitoring system (CEP monitoring) with Bender's residual current monitoring system. He opted for residual current monitoring with the decentralised RCMA423. Other alternatives would be the bus-controlled central 12-channel residual current monitoring system LINETRAXX® RCMS460-D and the decentralised single-channel RCMB300 series.

The system uses the corresponding measuring current transformers to measure fault and leakage currents in the earthed power supply and evaluate them directly. This made it possible to quickly determine which sub-distributions were causing the detected residual current of a few amperes without having to limit the functionality of the guest and owner areas.

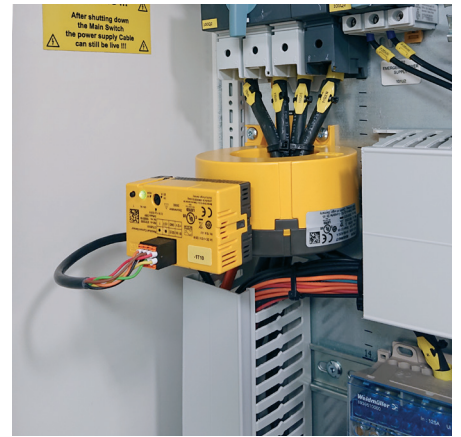
CTUB100 series measuring current transformer in the distribution units

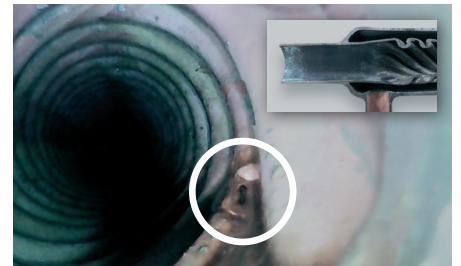
Fig. 1: Electrical spot corrosion at sea water cooled chiller condenser

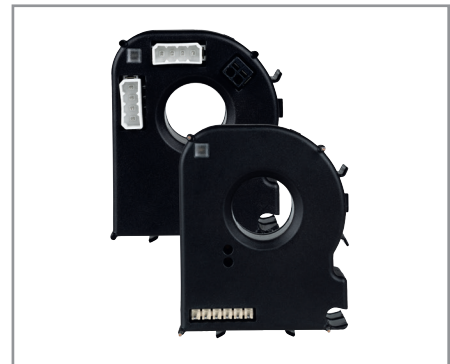
RCMB132 AC/DC

The RCMB132 AC/DC-sensitive residual current monitoring module product range enables the complete, continuous monitoring of each individual outgoing circuit. It has been tested in data centres and is also ideal for continual use in final circuits on board. This module can be refitted and local cabling laid on board during operation. It is installed on the circuit breakers in the sub-distribution and monitors the individual outgoing circuits. Evaluation takes place digitally via Modbus protocol, either to the next automatic sub-distribution or to a local operating panel. In addition to digital recording, LEDs are available to show the crew where a fault has occurred. Thanks to the comprehensive residual current monitoring on board, stray currents and incidents that endanger human life and installations can be avoided, even in complex systems.
